FIRE SAFETY FOLLOW UP INSPECTION

Factory Name	Taqwa Fabrics Ltd.		Accord ID	9530
Address	Boherachala Gilaberaeed, Kewa, Sreepur			
Initial Inspection Date	26-Apr-2014		Report Received Date	
Date of 1st Follow-up	25-Aug-2015	Date of 2nd Follow-up	21-Mar-2016	
Date of 3rd Follow-up	07-Jun-2016	Date of 4th Follow-up	06-Sep-2016	
Date of 5th Follow-up	27-Nov-2016	Date of 6th Follow-up	08-Feb-2017	
Date of 7th Follow-up	03-May-2017	Date of 8th Follow-up	22-Aug-2017	
Date of 9th Follow-up	03-Dec-2017	Date of 10th Follow-up	18-Apr-2018	
Date of 11th Follow-up	01-Nov-2018	Date of 12th Follow-up	2-Sep-2019	
Date of 13th Follow-up		Date of 14th Follow-up		
Inspected by	A N Faisal Ahmed

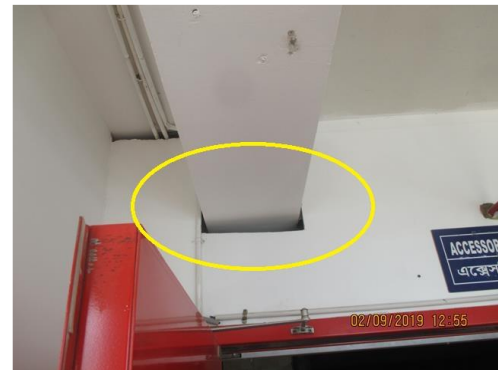
Item No	Accord Observation	Accord Recommendation	Timeline given by Accord	Comments after Physical Inspection	Supposed to complete (D/D/MM/YY YY)	Final Action Plan (Factory)	Status on the date of Inspection	Pictorial Evidence
1	Storage rooms and process areas throughout the building used for combustible storage are not separated by fire-rated construction.	Provide dedicated storage rooms separated by minimum 1-hr fire-rated construction. Where separate storage rooms are not feasible, provide defined storage areas and limit the storage arrangement as follows: - Maximum height of 2.4m and maximum area of 23m2 - If sprinkler protected: maximum height of 3.66m and maximum area of 93m2 Separate areas of unenclosed combustible storage by a minimum clear distance of 3m.	Within 3 months	On 08-02-17: Corrected. Proper fire rated separation has been completed for Accessories Store room, finished goods room and Cartoon room (4th Floor). On 22-08-17: On 3/12/17: Issue has been reopened. Sample section is located inside the storage area. On 18/04/2018: Sample section shall be separated from the accessories store as well as temporary store shall be within the recommended arrangements. On 01/11/2018: Corrected On 02/9/2019: Corrected as per previous follow up. Note: Factory shall seal penetration on accessories store.	21-May-2016	Done	Corrected

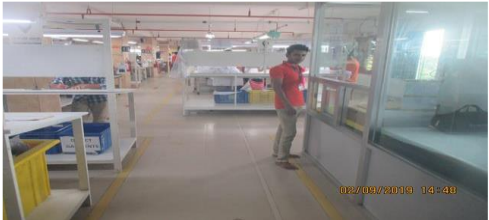
Item No	Accord Observation	Accord Recommendation	Timeline given by Accord	Comments after Physical Inspection	Supposed to complete (D D/MM/YY YY)	Final Action Plan (Factory)	Status on the date of Inspection	Pictorial Evidence
7	Sliding doors are provided at exit stairs.	Replace all sliding doors along the means of egress with side-hinged, swinging egress doors. If locks are required for security reasons, utilize special door locking features complying with NFPA 101.	Within 1 months	On 27-11-16: Corrected. On 08-02-17: Corrected. On 22-08-17: Corrected. On 3/12/17: Corrected. On 18/04/2018: Corrected. On 01/11/2018: Corrected On 02/9/2019: Corrected as per previous follow up.	25-Oct-2014	Done	Corrected	 
8	The width of egress aisles is less than 36-in. on floor 5.	Provide minimum aisle widths of 36-in.	Within 3 months	On 27-11-16: Corrected. On 08-02-17: Corrected. On 22-08-17: Corrected. On 3/12/17: Corrected. On 18/04/2018: Corrected. On 01/11/2018: Corrected On 02/9/2019: Corrected as per previous follow up.	25-Oct-2014	Done	Corrected

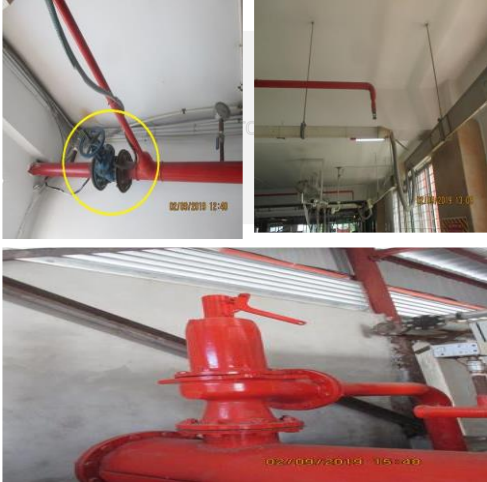
Item No	Accord Observation	Accord Recommendation	Timeline given by Accord	Comments after Physical Inspection	Supposed to complete (D D/MM/YY YY)	Final Action Plan (Factory)	Status on the date of Inspection	Pictorial Evidence
15	New Finding: The building has an occupied floor greater than 10 meter (33 feet) and its not provided with standpipe system as per NFPA 14 & 20. Location: Building-1 & 2.	Provide standpipe and hose system as per NFPA 14 & 20.	Within 25th February 2015.	<p>On 08-02-17: Corrected. Reviewed drawing from Accord was available during 6th follow-up inspection. Installation has been completed. Factory have been installed the fire pump which is certified by third party.(Commissioning of the system in-front of contractor/ 3rd party has been done by Accord).</p> <p>On 22-08-17: Corrected on 6th FU (I&C)</p> <p>On 3/12/17: Issue has been reopened. Diesel pump is not running during follow-up inspection. Sprinkler installation has been wrong. Zone control valve is missing at each floor.</p> <p>On 18/04/2018: Found same as it was before. Factory asked for time extension till September 2018. Not accepted.</p> <p>On 01/11/2018: Observed same as previous follow-up inspection. Factory asked for time extension till May 2019. Not accepted.</p> <p>On 02/9/2019: Wrong Sprinkler installation & Non listed valve accessories were observed. Detailed verification is required to find out the full functionality of the installed system.</p>	21-May-2016	Within May,2019 we will close this issue.	In Progress

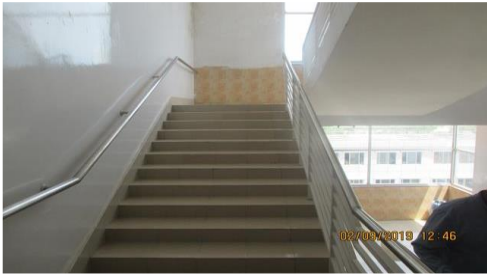
19	New Finding: Handrails are not provided in the exit stair.	Provide handrails on at least one side/both side of exit stair having a minimum height 34 in.	Within 25th September 2015.	On 27-11-16: Corrected. On 08-02-17: Corrected. On 22-08-17: Corrected. On 3/12/17: Corrected. On 18/04/2018: Corrected. On 01/11/2018: Corrected On 02/9/2019: Corrected as per previous follow up.	30-May-2016	Done	Corrected

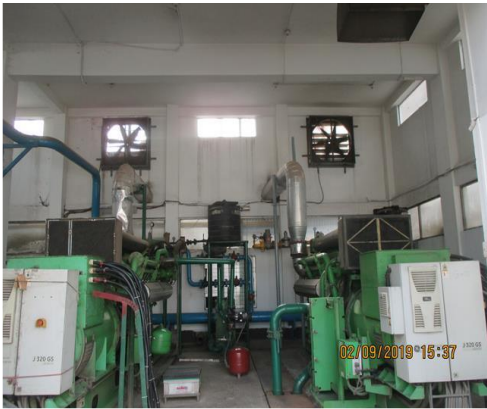
20	New Finding: Generator room is not properly separated by fire rated construction with other Occupancies/ Areas	1. Generator room shall be separated from other occupancies by a minimum 2-hr fire rated construction (wall, floor, slab etc.). Seal all penetrations and openings (door, window etc.) should be protected by 1.5-hr fire rated materials to maintain the fire separation if required. All exhaust systems shall discharge to the exterior of the building in a safe location. Or Relocate it to exterior of the building and maintain a minimum 3m (10 ft.) spatial separation distance from the building.	Within 25th September 2015.	On 27-11-16: Corrected. On 08-02-17: Corrected. On 22-08-17: Corrected. On 3/12/17: Corrected. On 18/04/2018: Corrected. On 01/11/2018: Corrected On 02/9/2019: Corrected as per previous follow up.	21-May-2016	Done	Corrected

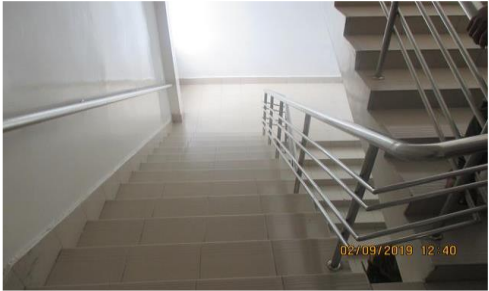
Item No	Accord Observation	Accord Recommendation	Timeline given by Accord	Comments after Physical Inspection	Supposed to complete (D D/MM/YY YY)	Final Action Plan (Factory)	Status on the date of Inspection	Pictorial Evidence
28	New Finding: The North-West stair was not provided with an adequate landing.	All stair shall be provided with landing with a minimum width of 36 in.	Within 3 months	On 27-11-16: Corrected. On 08-02-17: Corrected. On 22-08-17: Corrected. On 3/12/17: Corrected. On 18/04/2018: Corrected. On 01/11/2018: Corrected On 02/9/2019: Corrected as per previous follow up.	21-Jun-2016	Done	Corrected

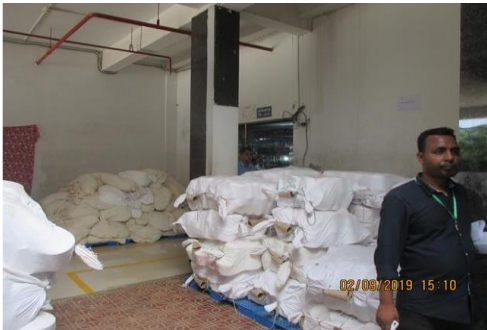
Item No	Accord Observation	Accord Recommendation	Timeline given by Accord	Comments after Physical Inspection	Supposed to complete (D D/MM/YY YY)	Final Action Plan (Factory)	Status on the date of Inspection	Pictorial Evidence
31	New Finding (5th Follow-up): Heavy fire load has been observed at the production floors due to the presence of large area of unenclosed combustible storages. Location: Dyeing Shed.	Provide defined storage areas and limit the storage arrangement as Maximum height of 2.4m and maximum area of 23m ² . Separate areas of unenclosed combustible storage by a minimum clear distance of 3m.	Within 1 month	On 27-11-16: New Finding. On 08-02-17: Corrected. On 22-08-17: Issue reopened. On 3/12/17: In progress. On 18/04/2018: It is required to maintain the recommended store arrangement. On 01/11/2018: Corrected On 02/9/2019: Corrected in dyeing shed. Note: In process storage area is not maintaining in main building on several floors.	31-Dec-2016	Corrected	Corrected

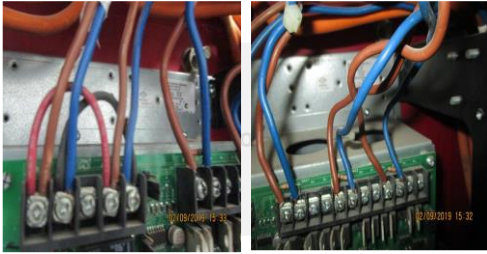
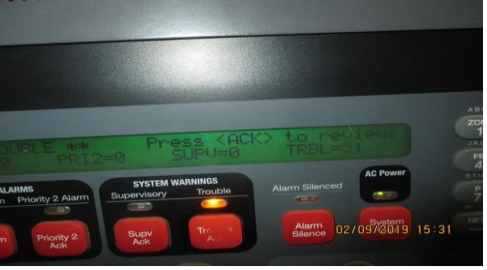
Item No	Accord Observation	Accord Recommendation	Timeline given by Accord	Comments after Physical Inspection	Supposed to complete (D D/MM/YY YY)	Final Action Plan (Factory)	Status on the date of Inspection	Pictorial Evidence
37	New Finding (9th FU): The fire alarm system is antiquated, not a listed system, and does not provide alarm and notification features consistent with acceptable standards.	Replace the fire alarm system with a new, listed addressable fire alarm system in accordance with NFPA 72.	Within 2 months	<p>On 3/12/17: New finding. Beam detector has not been functional on shed building. And still smoke detector is missing at different place.</p> <p>On 18/04/2018: Improper detector spacing and missing of detectors were observed during the follow-up inspection on various places. In detail verification required.</p> <p>Factory asked for time extension till June 2018. Not accepted.</p> <p>Factory asked for time extension till August 2018. Not accepted.</p> <p>Factory asked for time extension till September 2018. Not accepted.</p> <p>On 01/11/2018: FACP was not in proper functional mode. several trouble signal was present on the FACP. Moreover, detailed verification is required to find out the full functionality of the installed system.</p> <p>On 02/9/2019: It was found same as previous follow up. Sounder & MCP was missing on several required area. 51 nos trouble was present on FACP. System was found in abnormal & non functional mode due to jumper on NAC & SLC. Detailed verification is required to find out the full functionality of the installed system.</p>	02-Apr-2018	In Progress.	In Progress
