Structural Safety Inspection Report

Factory Name	Taqwa Fabrics Ltd.
Accord ID	9530
Factory Address	Boherachala Gilaberaed, Kewa, Sreepur
Date of Initial Inspection	16-Apr-2014
Date of Review Inspection	02-Jan-2020
Inspected by	Abu Zafar-Al-Mansur & Sadi Md. Zulker Nine

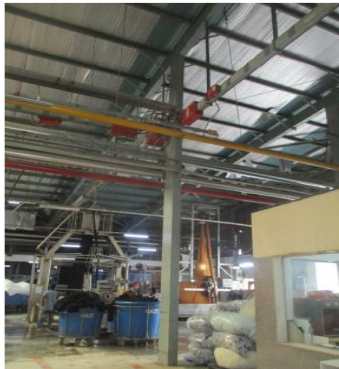
8	Slender Column to Dyeing Building.	Building Engineer to check the design and capacity of the slender circular hollow section supporting the steel roof and make any necessary alterations.	within 06 week	Corrected.	10-Jan-2018	<p>On 25/08/2015: The have replaced previous slender column with new I section steel column.</p> <p>On 06/09/2016: Still pending; factory management replaced the slender column with new steel I section column but this issue is not covered in DEA report. Factory management will submit all other documents of steel structures as per requirement of initial inspection report within october,2016.</p> <p>On 05-Feb-2017: Steel joist column(152mmx6mmx443mmx8mm) was found in place of slender column. Factory submitted the design analysis report on 02-Jan-2017 to ACCORD and the report is under review. After getting acceptance, factory is required to follow the recommendation of the accepted report.</p> <p>On 02-April-2017: This issue will be covered in DEA. After getting acceptance, factory is required to follow the recommendation of the accepted report.</p> <p>On 17-Dec-2017: DEA was accepted on 22th November 2017. During inspection, factory has started the structural alteration as per accepted DEA. All the remedial works are required to be completed within 10th January 2018. Factory management must complete all the remediation within given timeline.</p> <p>On 16-Jul-2018: Design adequacy has been checked as part of DEA which had accepted from ACCORD on 22-Nov-2017. As per DEA recommendation, retrofitting is required for the go down building and dyeing building. During inspection, retrofitting work of the go down building was found completed. 20% retrofitting work of dyeing building is yet to be completed.</p> <p>On 09-Oct-2018: This issue has been covered in DEA. DEA of Dyeing building was accepted by ACCORD on 20th November 2017. Factory completed retrofitting works. During retrofitting verification, some mismatch was found. At site; joint details of dual L section for bottom cord of truss member doesn't match with retrofitting drawing. Factory is required to construct as provided in retrofitting drawing or submit revised design documents to ACCORD within 7 days of receiving the report. Joint of wall bracing and roof bracing does not match with drawing and found inadequate. Factory repaired joint of bracing and sent pictorial evidence. Gap was also found at connection plate. All the joint and connection plate is required to be re-checked and repaired which will be verified in next inspection.</p> <p>On 29-May-2019: Factory submitted revised documents of 2 storied steel building as per mismatch found in verification inspection. Revised documents got re-acceptance by Accord on 1st November 2018. retrofitting was completed. During inspection, no discrepancy was found.</p> <p>On 02-Jan-2020: Corrected from previous issue. DEA has been accepted and factory has completed all retrofitting works in Dyeing building.</p>	Corrected

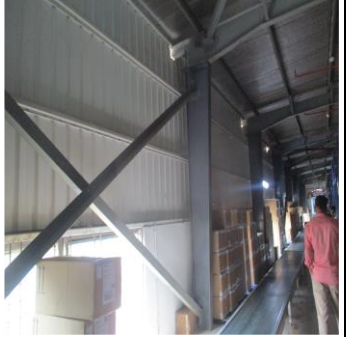
Item No	Accord Observation	Accord Recommendation	Accord Timeline	Final Action Plan	Final Timeline(dd-mm-yyyy)	Comments after Physical Inspection	Progress Status	Pictorial Evidence
10	Missing longitudinal bracing to Raw Materials Godown Building & Dyeing Building	Building Engineer to check the design of the building for longitudinal stability and provide roof and wall bracing as necessary.	within 06 week	Corrected.	10-Jan-2018	<p>On 25/08/2015: We found longitudinal bracing in Dyeing building, not in Go down building. Finally this issue will be covered in DEA</p> <p>On 06/09/2016: Still pending; During inspection bracing found installed in dyeing building only. Factory management will submit all other documents of steel structures as per requirement of initial inspection report within october,2016.</p> <p>On 05-Feb-2017: Factory submitted the design analysis report on 02-Jan-2017 to ACCORD and the report is under review. In addition, bracing was installed but it was found loose. After getting approval of the report, factory is required to install the bracing as per suggestion of the accepted report. In addition, the dying shed was found connected with adjacent another shed which belongs to another factory. Factory will consider the connection in their analysis.</p> <p>On 02-April-2017: This issue will be covered in DEA. After getting acceptance, factory is required to follow the recommendation of the accepted report.</p> <p>On 17-Dec-2017: DEA was accepted on 22th November 2017. During inspection, factory has started the structural alteration as per accepted DEA. All the remedial works are required to be completed within 10th January 2018. Factory management must complete all the remediation within given timeline.</p> <p>On 16-Jul-2018: Design adequacy has been checked as part of DEA which had accepted from ACCORD on 22-Nov-2017. As per DEA recommendation, retrofitting is required for the go down building and dyeing building. During inspection, retrofitting work of the go down building was found completed. 20% retrofitting work of dyeing building is yet to be completed.</p> <p>On 09-Oct-2018: This issue has been covered in DEA. DEA of building was accepted by ACCORD on 20th November 2017. Factory completed retrofitting works. During inspection, mismatch was found in between drawing and actual site condition. Opening has been made in floor slab by cutting sub-beam and deck slab at 2 storied ware house. Factory is required to construct as provided in drawing or submit revised design documents to ACCORD within 7 days of receiving the report. Gap was found at connection plate. All the connection plate is required to be re-checked and repaired which will be verified in next inspection.</p> <p>On 29-May-2019: Factory submitted revised documents of 2 storied steel building as per mismatch found in verification inspection. Revised documents got re-acceptance by Accord on 1st November 2018. During inspection, no discrepancy was found.</p> <p>On 02-Jan-2020: Corrected from previous issue. DEA has been accepted and factory has completed all retrofitting works in both buildings</p>	Corrected

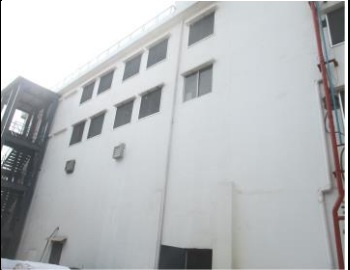
14	Heavy loading in Main Building	Implement actions arising from investigation.	within 06 month	Corrected.	31-Dec-2016	<p>On 25/08/2015: Strengthening work should be done after getting approval from Accord.</p> <p>On 06/09/2016: Loading found below 1kpa except 4th floor packing zone of main building. 4 no's plastic water tank (1500 letter) found incorporated in load plan. DEA got partially approval on 4th September, 2016 but retrofitting is required for packing section to factory building. So this issue will be corrected after the completion of retrofitting.</p> <p>On 05-Feb-2017: Factory got partial DEA acceptance for the main building. But during verification, some discrepancy was found. Factory is required to submit the corrected DEA report to ACCORD and implement the recommendation of accepted DEA.</p> <p>On 02-April-2017: Factory has been carried out Detail Engineering Assessment(DEA). DEA has been accepted by Accord. As per accepted DEA recommendation, factory has carried out strengthen works. So factory can follow final loading plan. Final loading plan was posted on floors. Loading was found as per approved load plan</p> <p>On 17-Dec-2017: Floor loading observed within the allowable limit. Issue was found corrected from previous follow up inspection.</p> <p>On 16-Jul-2018: Corrected from previous inspection.</p> <p>On 09-Oct-2018: This issue was corrected from previous inspection. Load plan was produced as part of DEA. Factory completed retrofitting works and posted final load plan. During inspection, Loading was found more than 42 psf. After that factory reduced loading and sent pictorial evidence which found satisfactory.</p> <p>On 29-May-2019: This issue is corrected in previous follow-up inspection.</p> <p>On 02-Jan-2020: Corrected from previous follow-up inspection. DEA has been accepted and factory has completed all retrofitting works in Main building</p>	Corrected
